**COMBAT MAINTENANCE CONCEPTS AND REPAIR  
TECHNIQUES FOR HELICOPTER AIRFRAME STRUCTURES**

Sikorsky Aircraft Division  
United Technologies Corporation  
Stratford, Connecticut 06602

January 1981

Final Report for Period September 1979 - July 1980

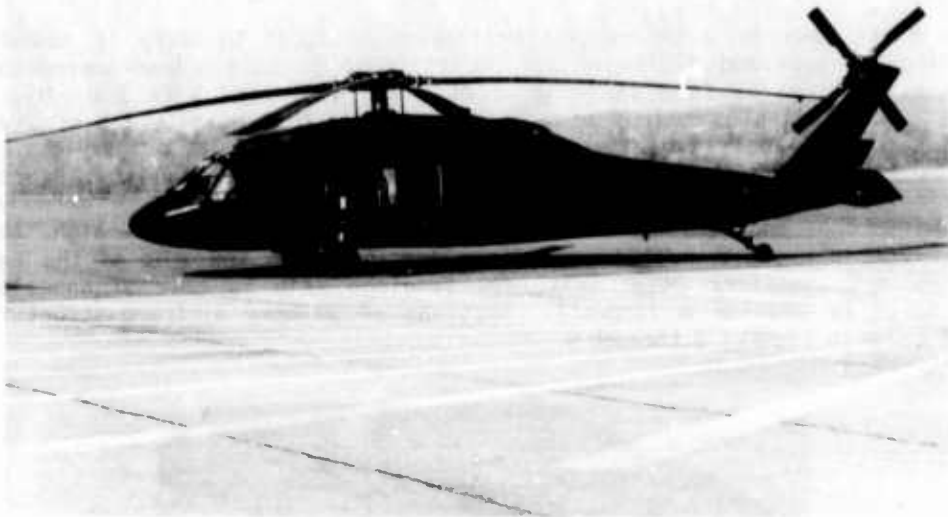
Figure 1. UH-60A Black Hawk Helicopter

The UH-60A Black Hawk helicopter (Figure 1) is an excellent candidate for the study of combat maintenance concepts for airframe structures. The first of the Army's new technology aircraft to enter service, the Black Hawk is designed to be highly survivable in combat.

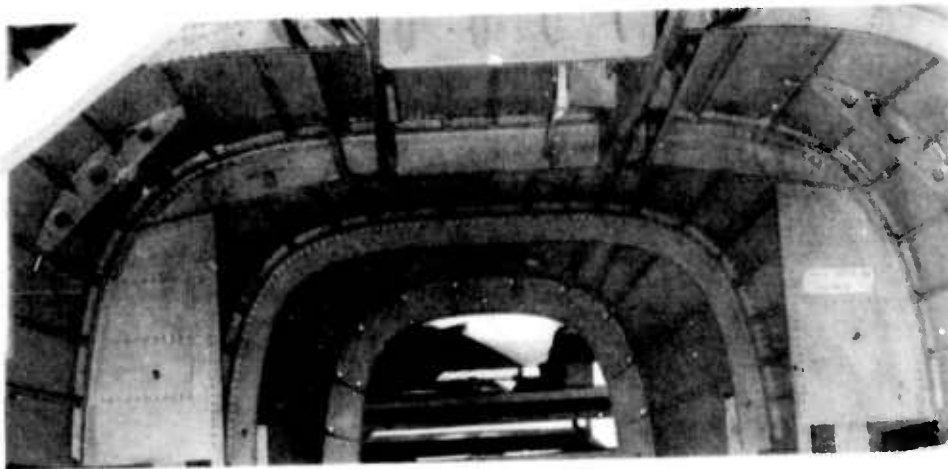
Figure 3. Rear Fuselage Interior Roof Structure

The Black Hawk is a twin-engine helicopter designed to carry 11 combat-equipped troops and a crew of 3. The airframe is an aluminum semi-monocoque structure 51 ft 3 in. long, 7 ft 9 in. wide, and 5 ft 9 in. high. The six principal sections of the airframe are the cockpit, cabin, rear fuselage, tailcone, tail rotor pylon, and stabilator. The primary structure is comprised of aluminum skins with rolled or extruded aluminum stringers. The fuselage frames are built-up structures with extruded aluminum caps and aluminum sheet webs. In areas where loads are high, the fuselage frames are machined aluminum forgings. In the area of the engines and auxiliary power unit, the fuselage skin is made of annealed titanium to provide a firewall. Sections of primary airframe structure are shown in Figures 2 through 6.

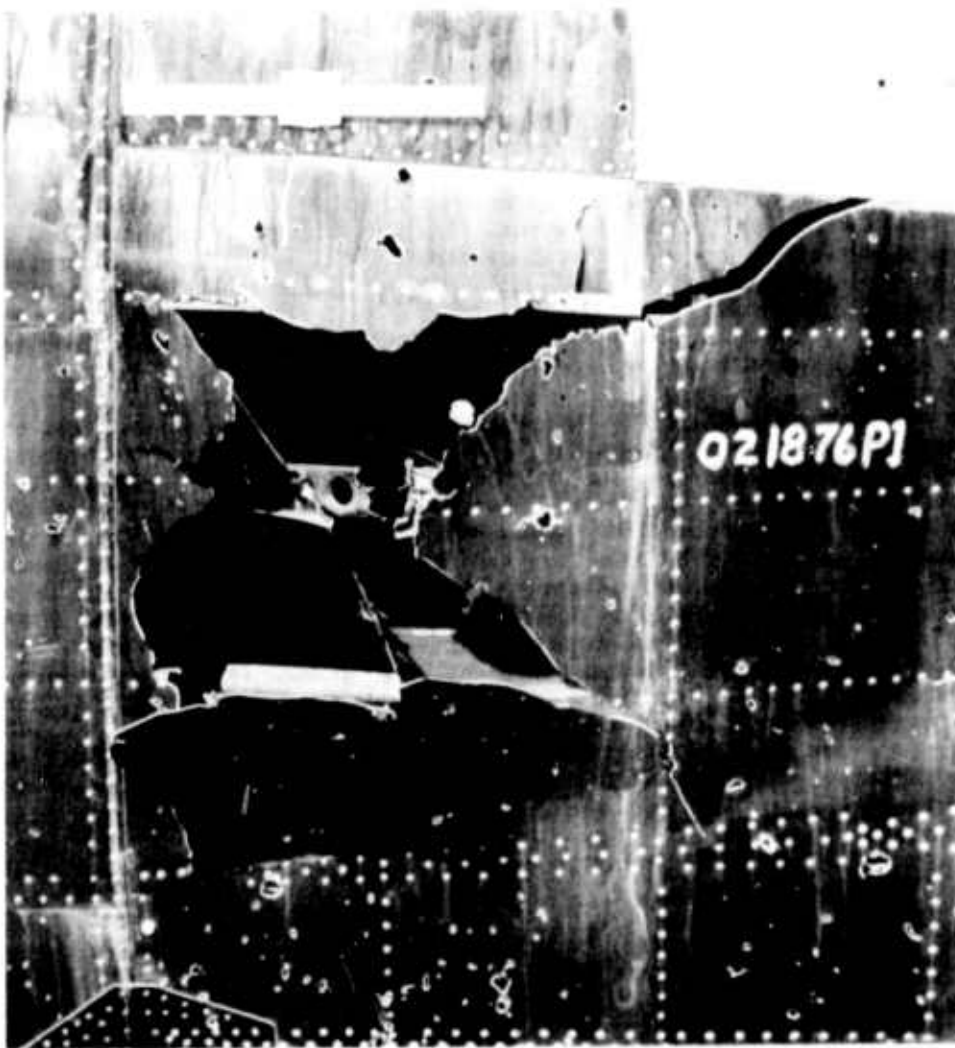
Figure 9. Exit-Side Damage Caused by the HEI Projectile

exploding projectile penetrate the opposite skin and produce massive damage. Total disintegration occurs in the path of the large, closely spaced, high energy fragments directly ahead of the projectile. The surrounding structure suffers multiple penetrations by dispersed fragments. Shock wave and overpressure effects produce tearing and distortion of the metal (Figure 9). When the HEI projectile engages major structure such as frames and beams, expected damage includes the removal of large sections of material and buckling and distortion of the structure. In cases where the projectile impacts a thin light structure such as a tail fin, complete penetration may occur before the explosion takes place, greatly diminishing the damage sustained.

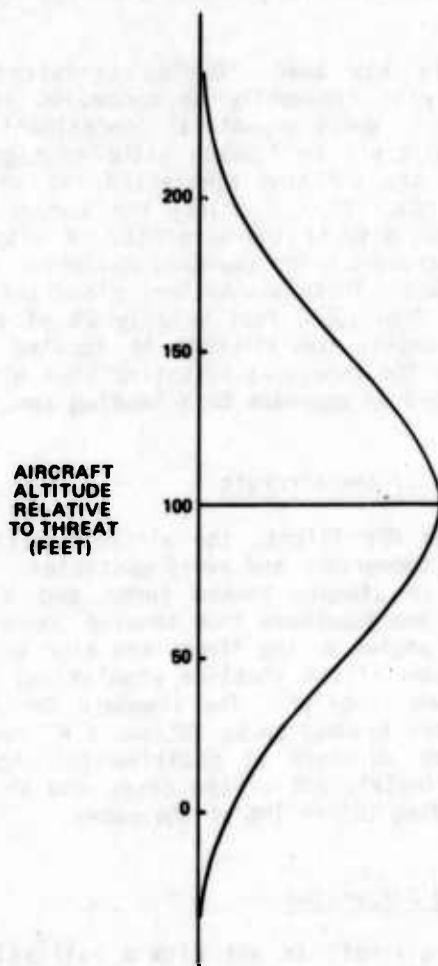
Figure 15. Assumed Distribution of the Aircraft Altitude Relative to the Threat

the ground-based threat (Figure 15). The standard deviation in altitude was assumed to be 50 feet. This implies that 2% of the time the aircraft will be flying below a threat situated on elevated terrain. Only 2% of the time would the aircraft be operating at an altitude of 200 feet or more above the threat.
